# Seismic Performance of Steel Pipe Pile to Cap Beam Moment Resisting Connections

## Final Report

North Carolina State University  
Raleigh, North Carolina

January 2013

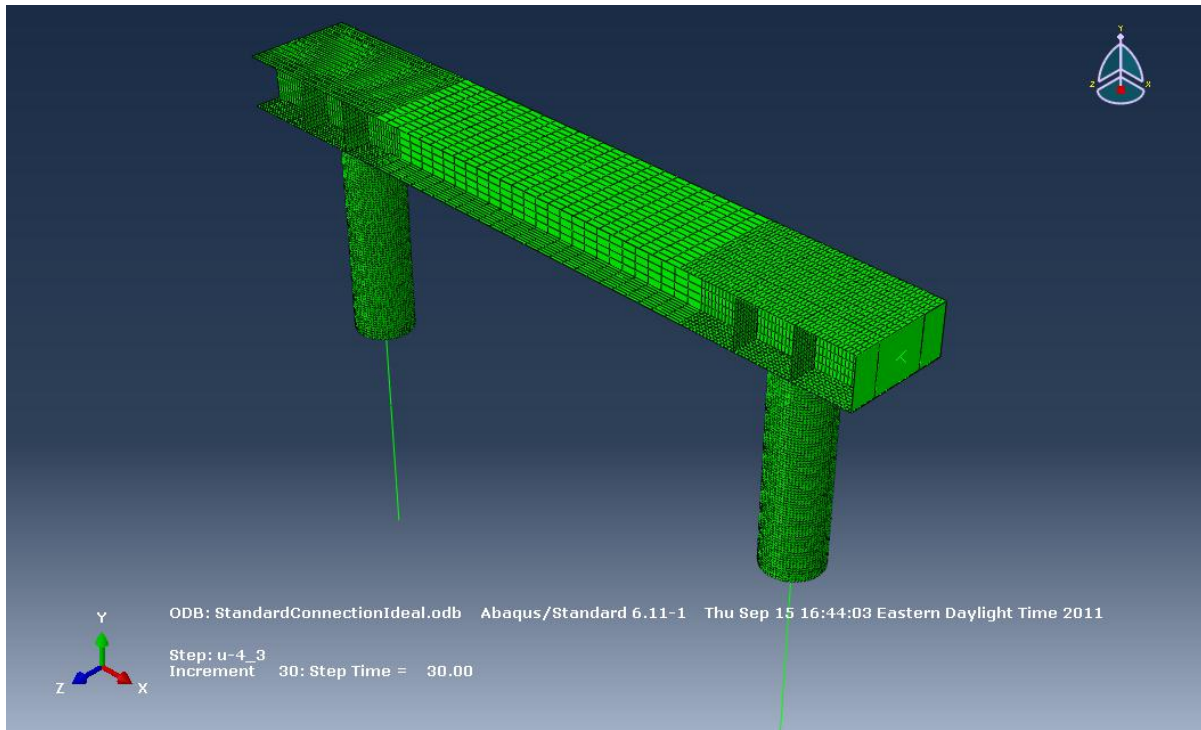
However, this basic modeling procedure was shown to capture local buckling, connection behavior, global behavior, and stress and strain concentrations over reasonably sized regions in a manner comparable to that of the experimental investigations. In addition, some models required the definition of hard contact between elements within the analysis. This was achieved with an Abaqus feature that allows for the definition of hard contact between surfaces independent parts and allows separation after the contact occurs. Additional specific details related to the various models developed in this research will be discussed where applicable.

**Figure 4.16 Steel Pier Finite Element Model**

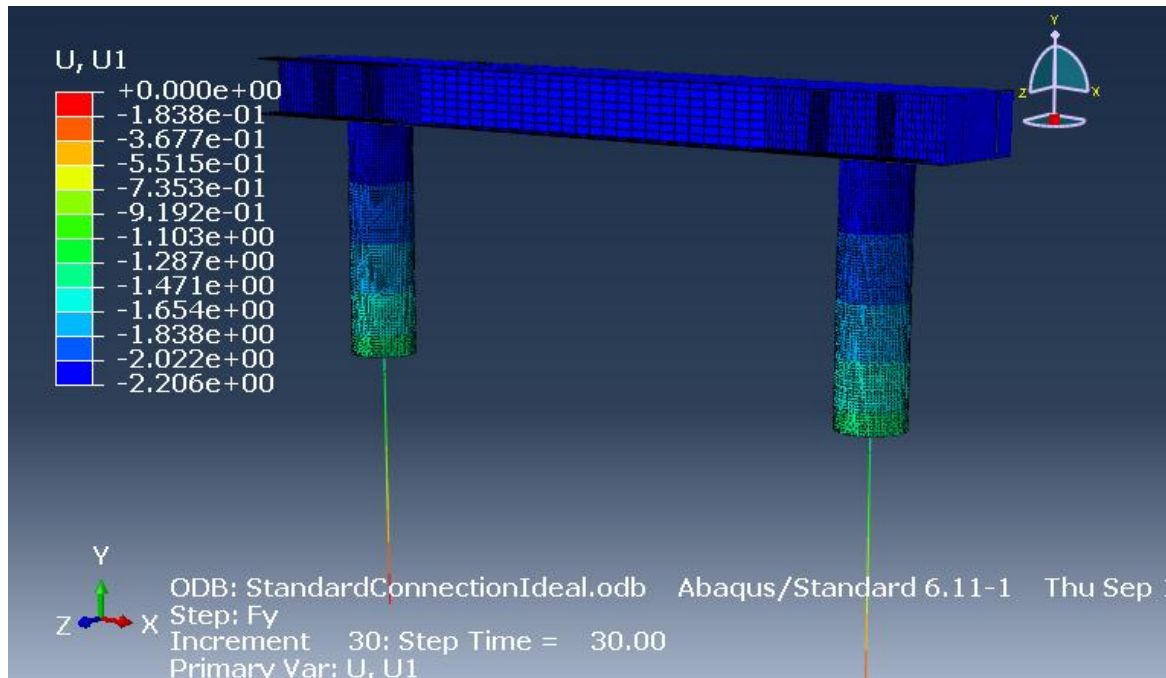
**Figure 5.8 Standard Welded Connection Detail – FEM First Yield Conditions**

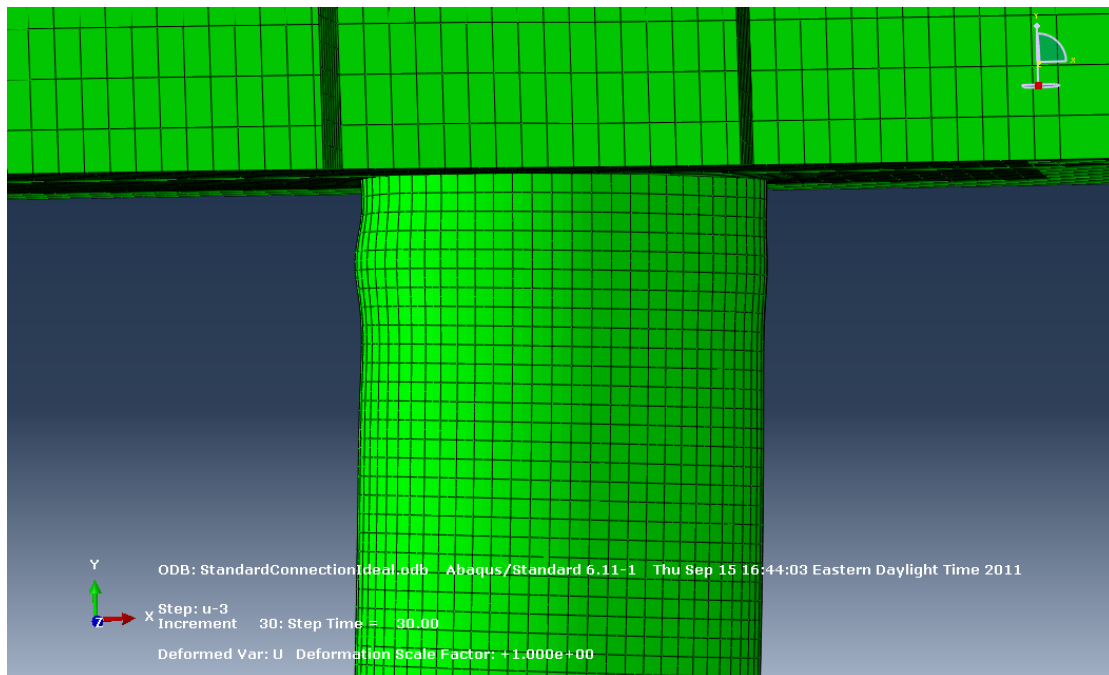
The results of the simulation showed the onset of local buckling to occur at the ductility 3 level as shown in Figure 5.9. Note this was the same ductility level at which minor levels of local buckling were noted to occur in each experimental evaluation with the exception of the pier containing fillet welds which was limited to a maximum displacement ductility of 2. The analysis, which did not have the capability to capture material fracture, was conducted through the ductility 4 cycles which showed the severity of the buckled region to propagate as shown in Figure 5.10. This was similar to that of the first experimental evaluation with CJP welds and full depth reinforcing fillet welds which was able to survive the ductility 4 cycles and showed the buckled region to propagate in severity. Hence, the analytical results indicated that the desirable form of pile wall local buckling leading to gradual strength loss over multiple cycles may control, should connection region cracking be mitigated as shown in Figure 5.11. However, mitigation of connection region cracking was not experienced in any of the experimental evaluations as has been highlighted.

**Figure 5.9 FEM – Onset of Local Buckling at the Ductility 3 Level**

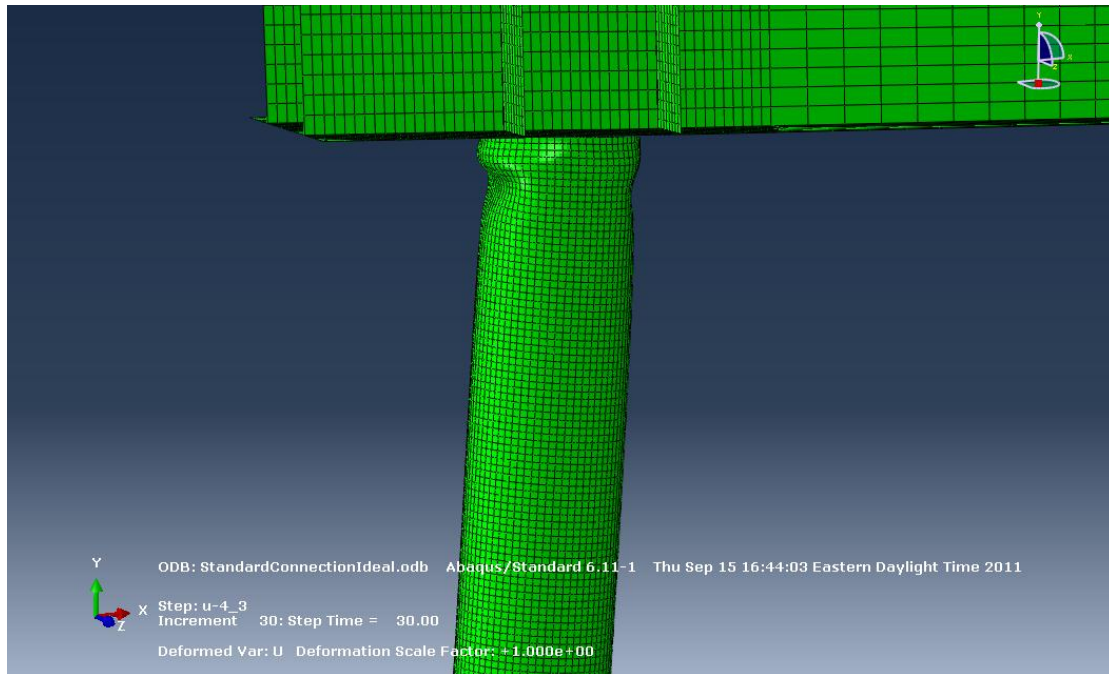
**Figure 5.10 FEM – Propagation of Local Buckling at Ductility 4 Level**

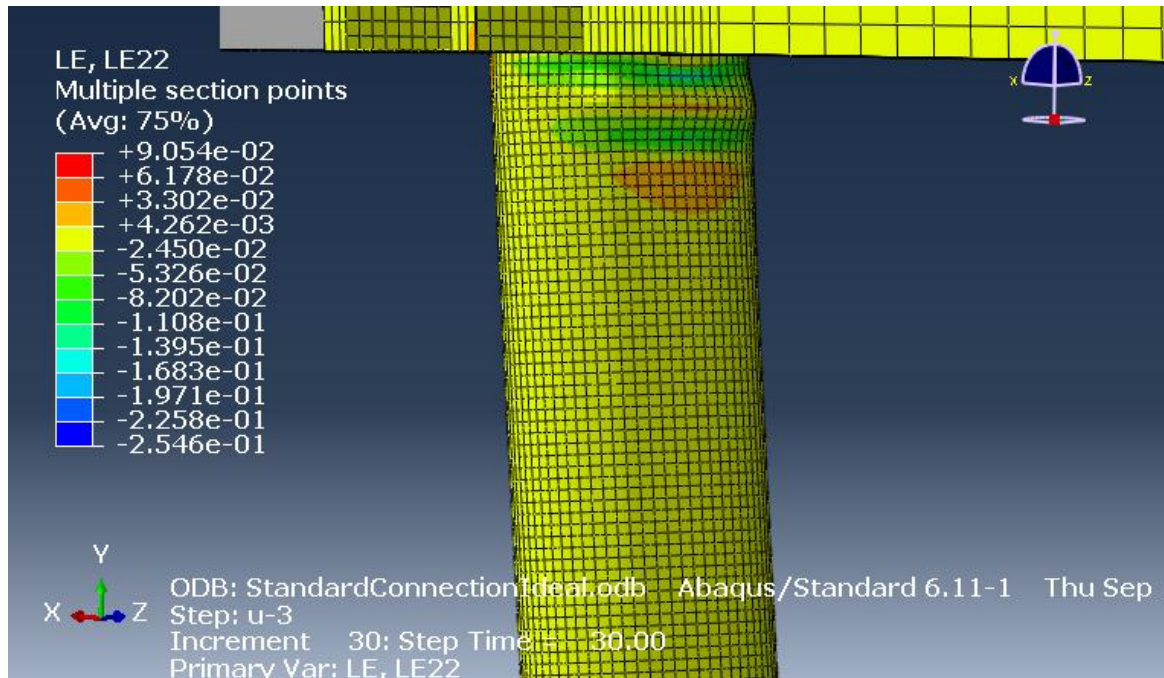
**Figure 5.16 FEM – Compression Strains at Weld Toe Region**

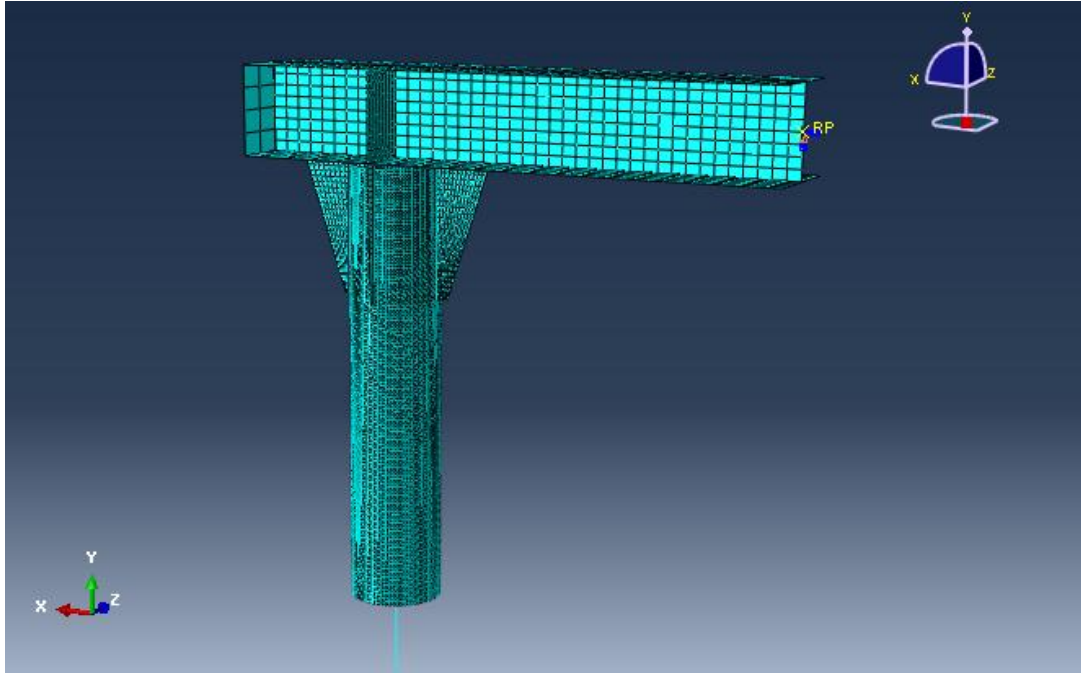
Shell element based Finite Element Analysis was conducted prior to testing of the system in an effort to predict specimen behavior. The model consisted of 8 node linear shell elements that incorporated a multi-linear kinematic hardening material model which was based on actual in-house tensile material tests. The model also incorporated non-linear geometric formulations in order to capture the effects of local buckling on the overall specimen behavior. The three cycle set load history utilized in the simulation was based on the theoretical first yield force assuming a pile hinging mechanism below the gusset plate region and a FEA predicted first yield displacement of 1.56 in. In the case of the kerf connection, the analytical model, shown in Figure 6.11, took advantage of the relatively symmetric nature of the two column pier configuration to reduce the model size by employing a roller boundary condition at the centerline of the pier.

**Figure 6.11 Kerf Connection Finite Element Model**

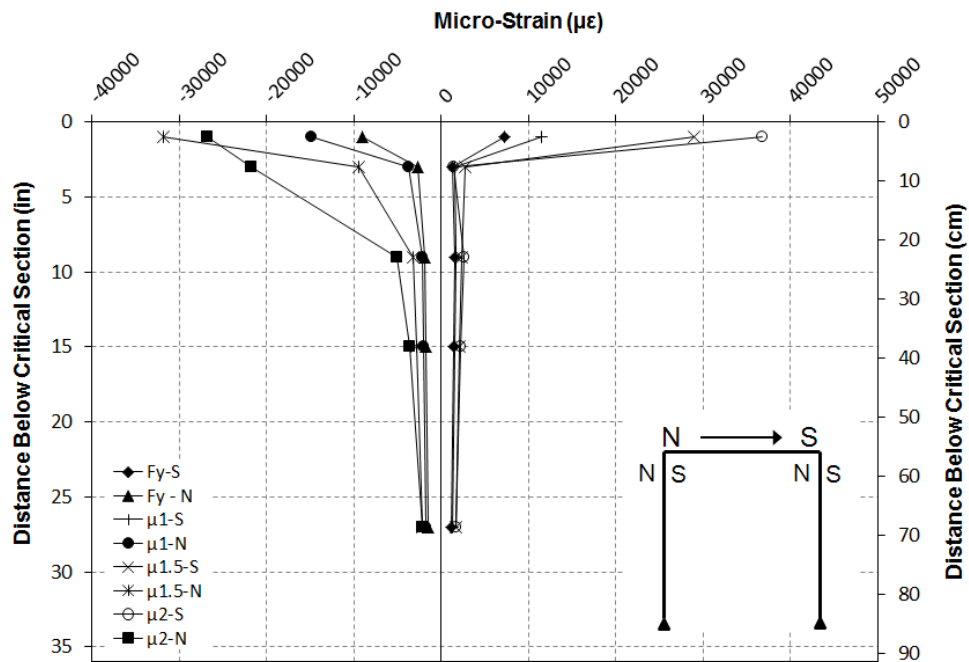
Figure 6.21 Test 1 - S. Col. - 1st Positive Cycles Strain Profiles

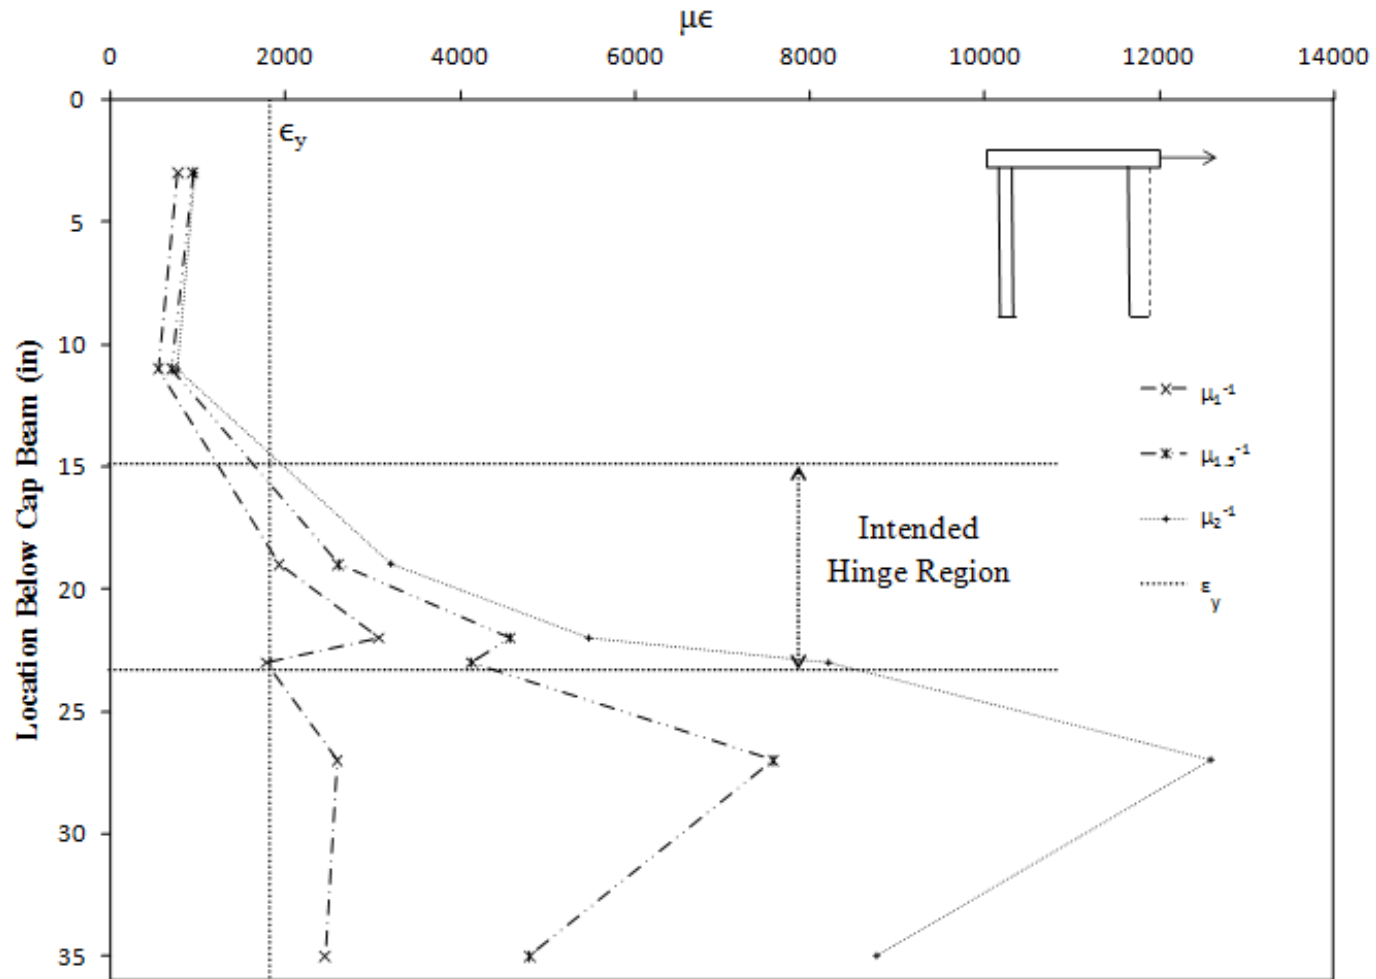
Figure 6.48 Strain Gauge Vertical Strain Profile – North Column North Face Push Direction

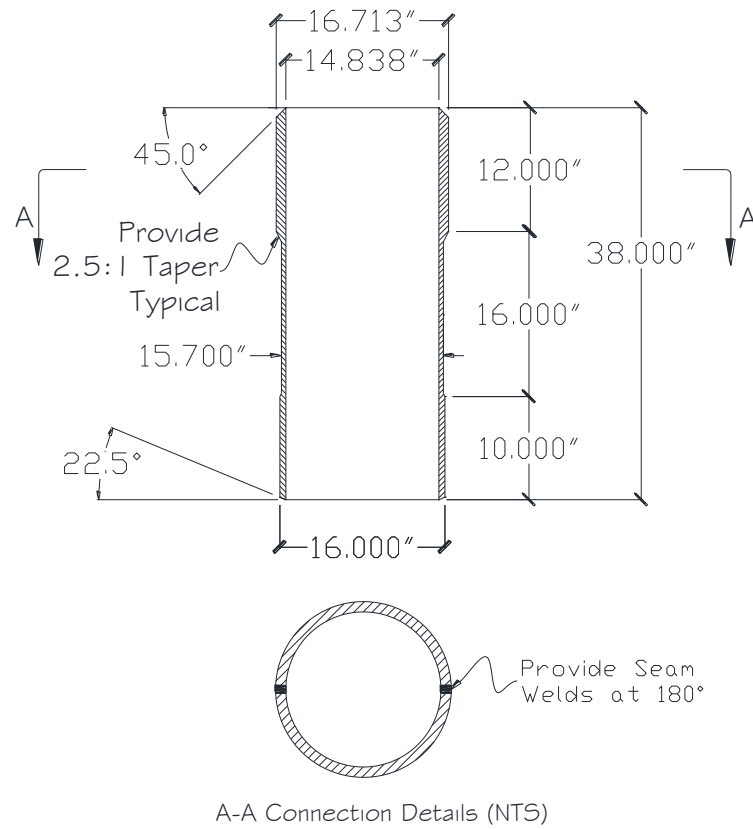
**Figure 6.52. Modified Column Capital Details**

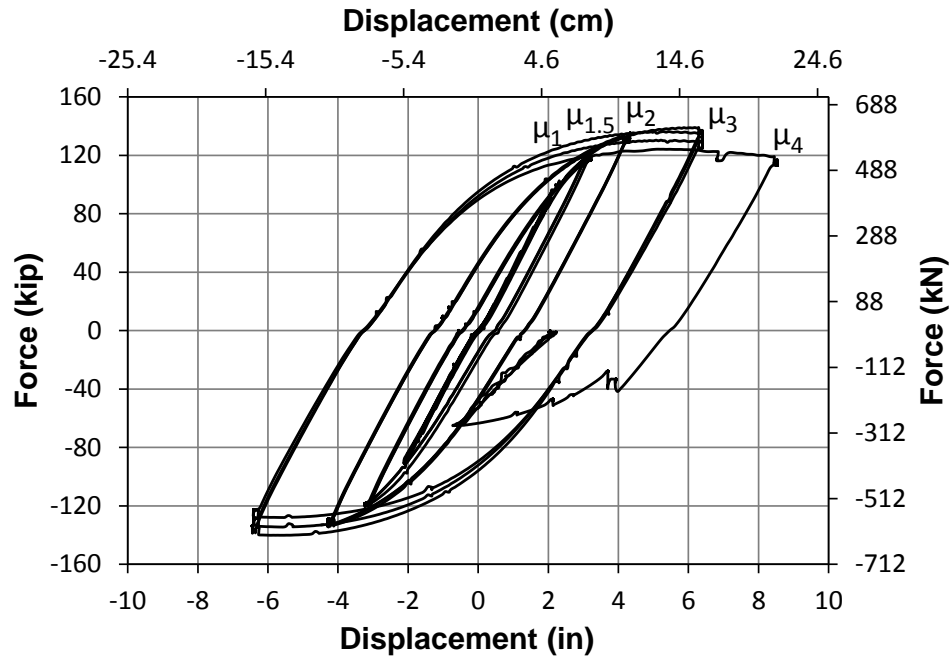
Figure 6.60 Phase 2 Test 3 Modified Capital Force-Displacement Hysteresis

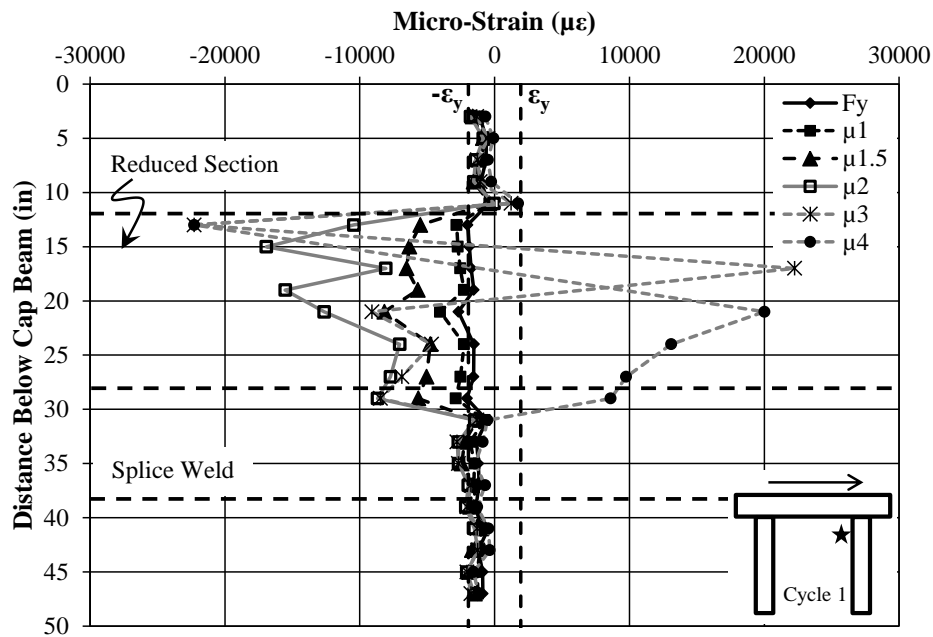
**Figure 6.70 South Column North Face – Positive Cycle 1 Vertical Strain Profile**

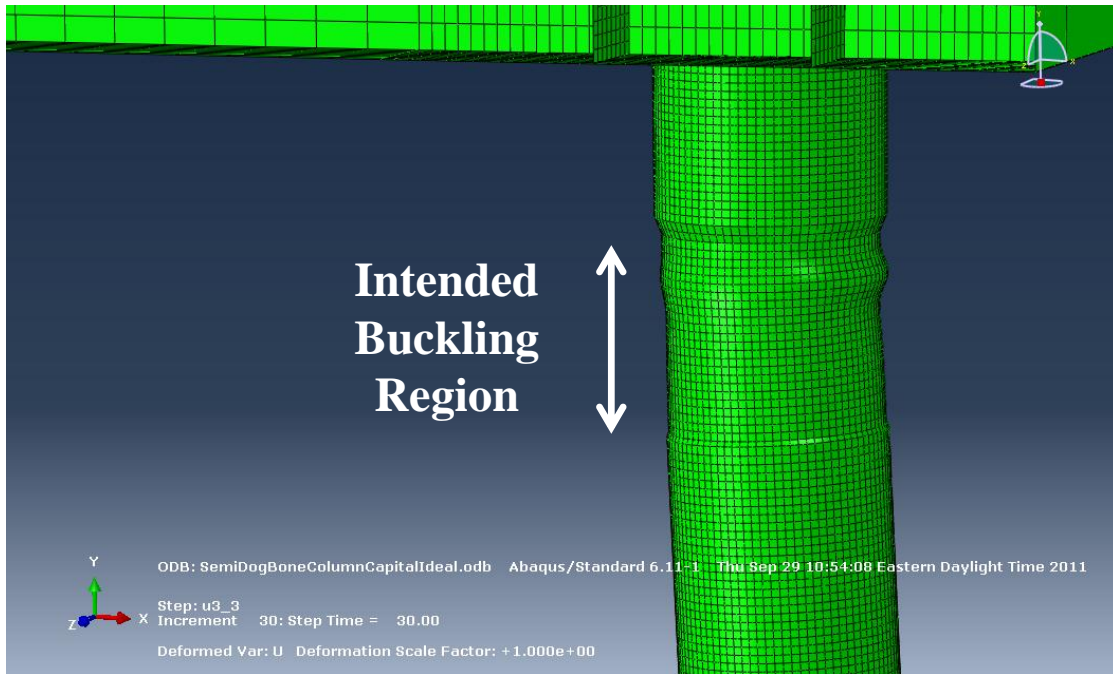
**Figure 6.76 Modified Column Capital – Initial FEM Simulation Response**

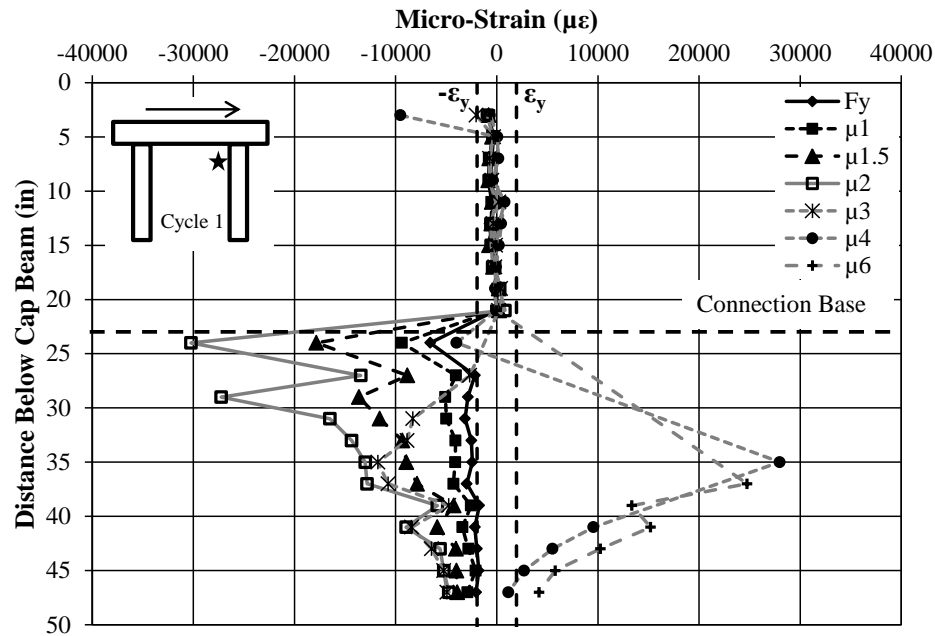
Figure 6.103 South Column North Face – Positive Cycle 1 Vertical Strain Profile

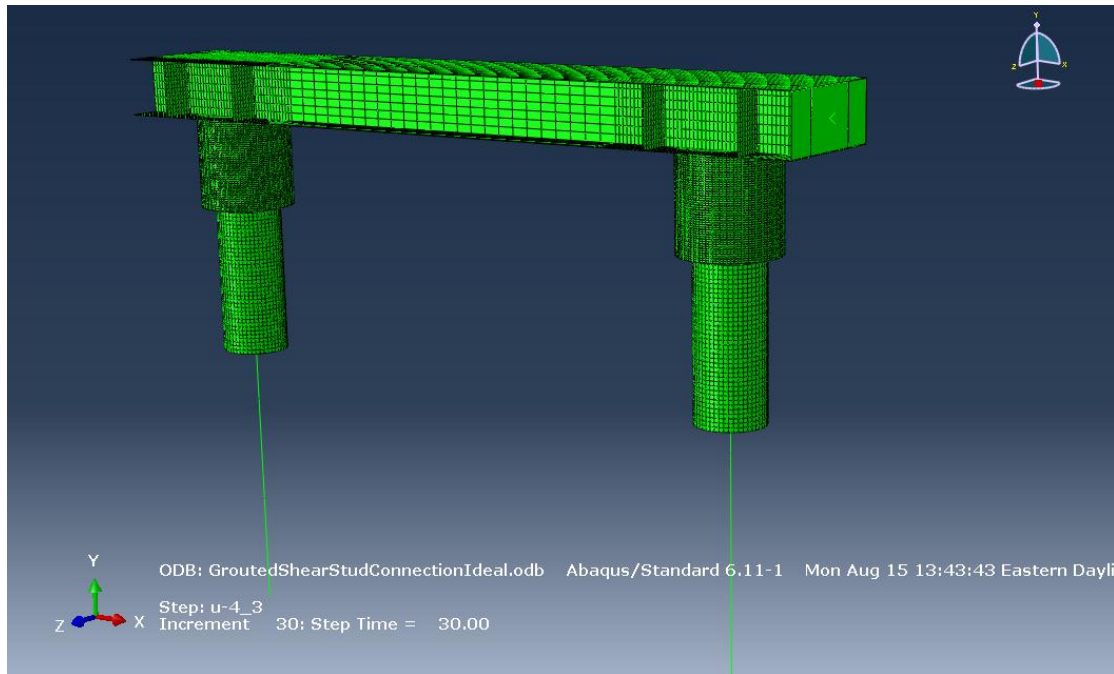
For simplicity, the grout material was modeled with elastic material behavior and the resulting analytical errors will be discussed where applicable. Due to the harsh geometric conditions required to directly model the shear studs, connection between the grout and pipe elements was achieved by utilizing fastener definitions that considered the geometric pattern of the shear studs to join appropriate areas of each mesh. The model, shown in Figure 6.107, was subjected to a quasi-static displacement history matching that of the test 2 specimen to analytically replicate the experimental procedure.

**Figure 6.107 Abaqus FEM G.S.C. Pier**

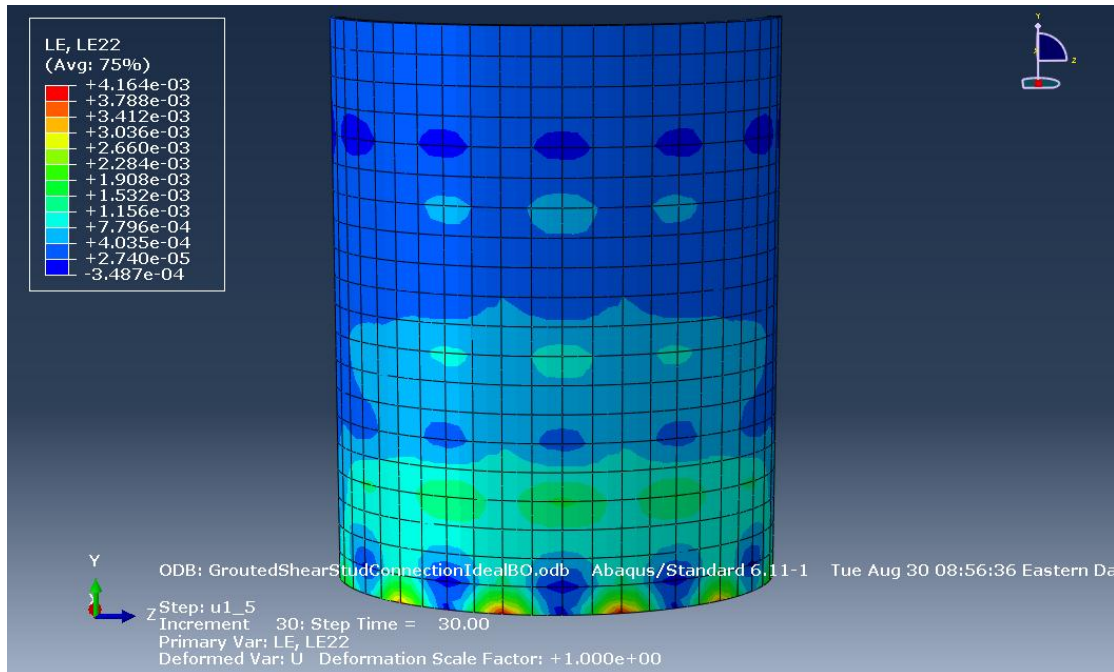
**Figure 6.118 Pile Strains in the Connection Region Above the First Row of Studs**

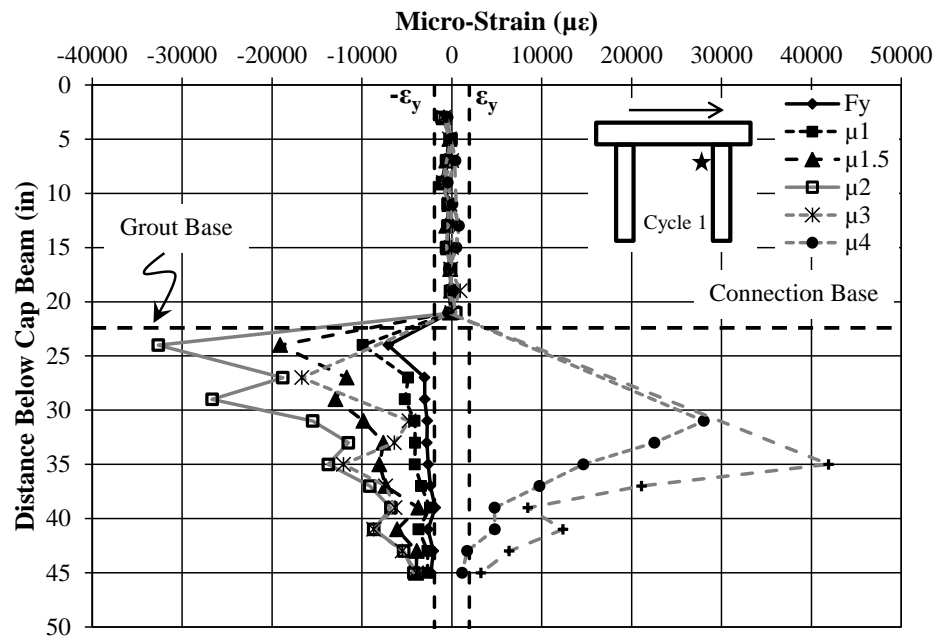
**Figure 6.134 South Column North Face – Positive Cycle 1 Vertical Strain Profile**

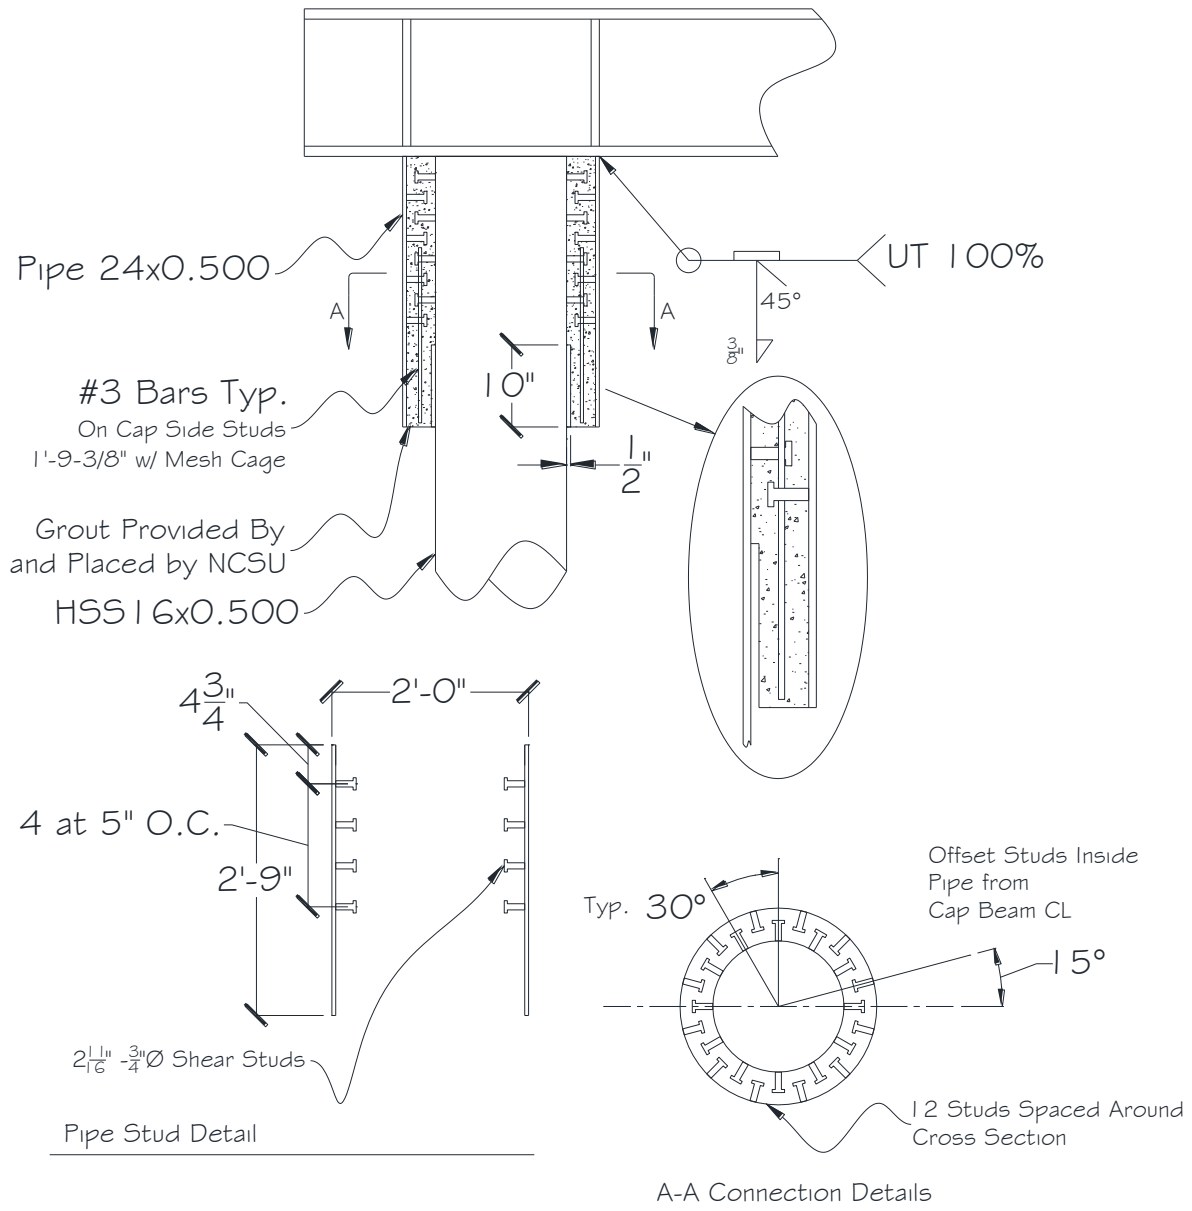
**Figure 6.144 B.R. Grouted Shear Stud Connection Details**

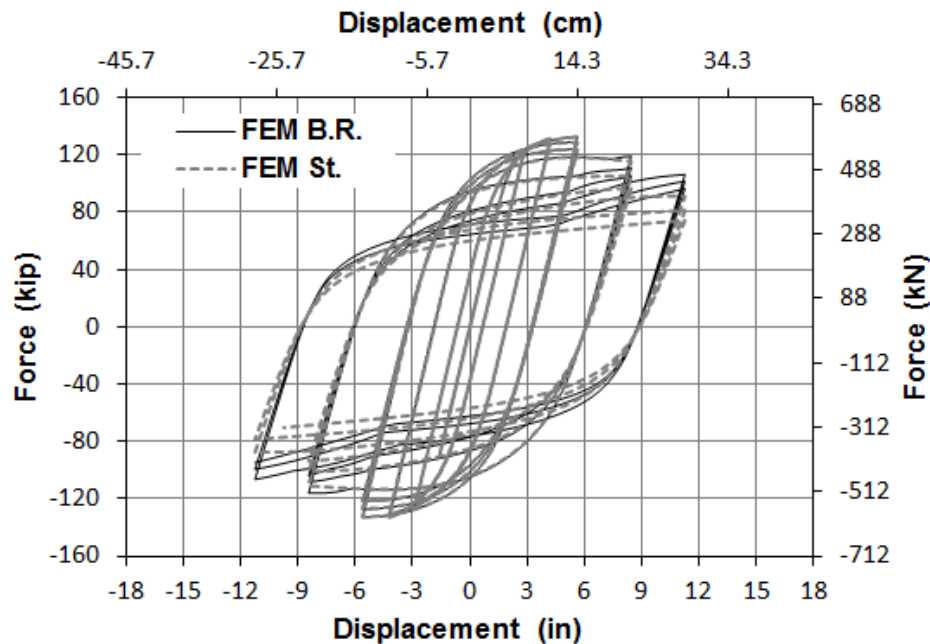
**Figure 6.145 FEM 3/4 in. Block-Out vs. FEM Standard G.S.C.**

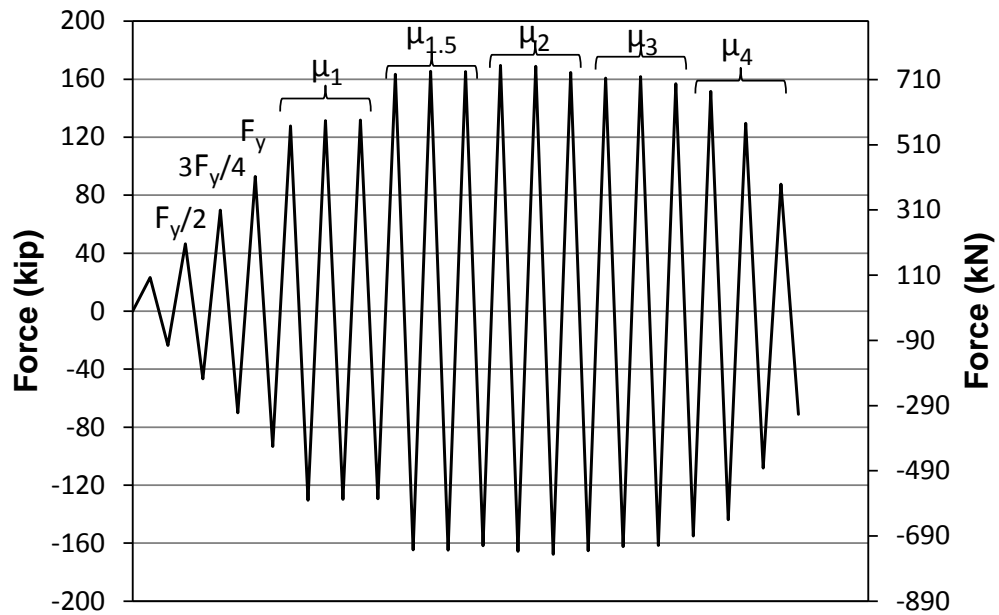
Figure 6.149 Modified B.R. – G.S.C. Experimental Load History

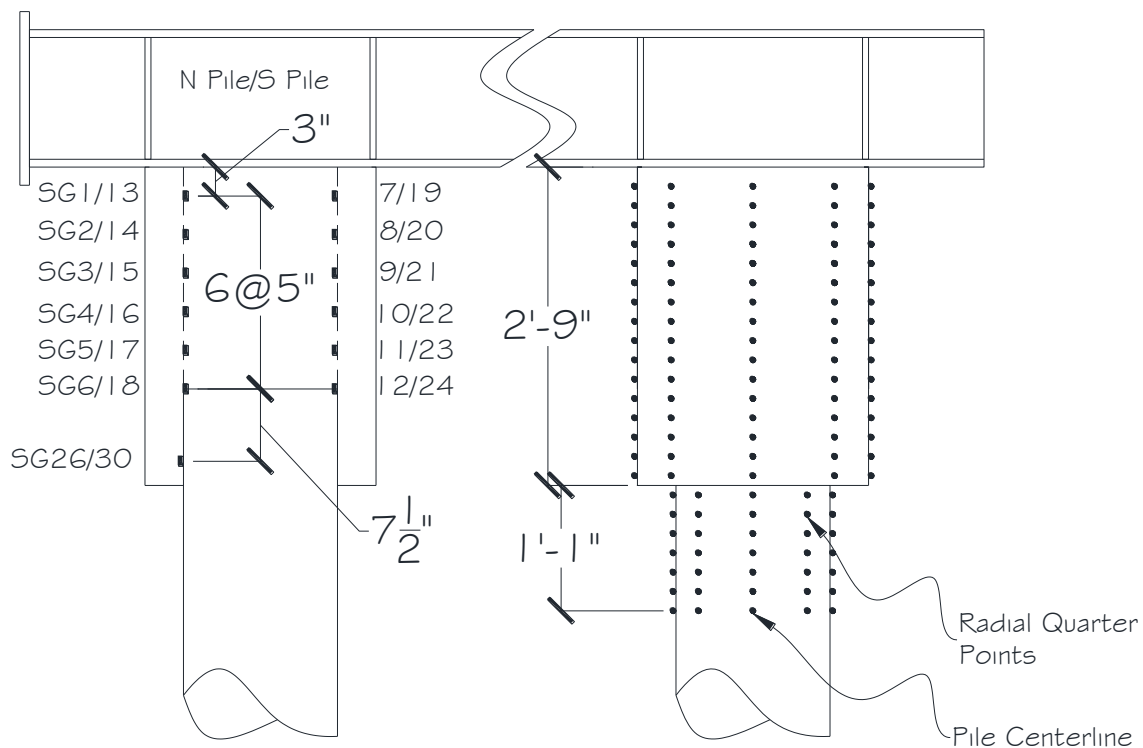
Similar to the prior grouted shear stud connection tests, the behavior of the modified buckling restrained configuration was monitored during testing using both the Optotrak system as well strain gauge instrumentation. As shown in Figure 6.151, the basic Optotrak marker grid remained the same with the exception of the instrumented stub pile region being longer as a consequence of the design configuration. Again, internal strain gauges were used to monitor the strain gradient along the pile wall in the connection region. However, in the case of the modified configuration, strain gauges were also placed inside the block out region on the outside of the HSS16x0.500 pile prior to placing the block-out and grout material, such that strains could be monitored in this region since no Optotrak data could have been collected within the internal region.

**Figure 6.151 Modified B.R. – G.S.C. Instrumentation Layout**

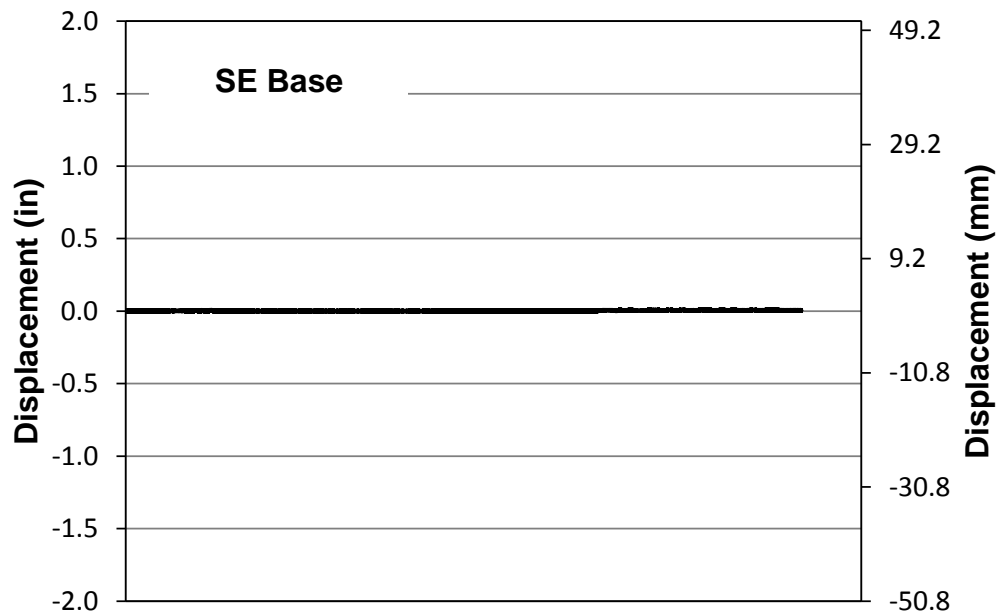
**Figure 6.155 Test 5 – SE Base Displacement Reading Through Test**

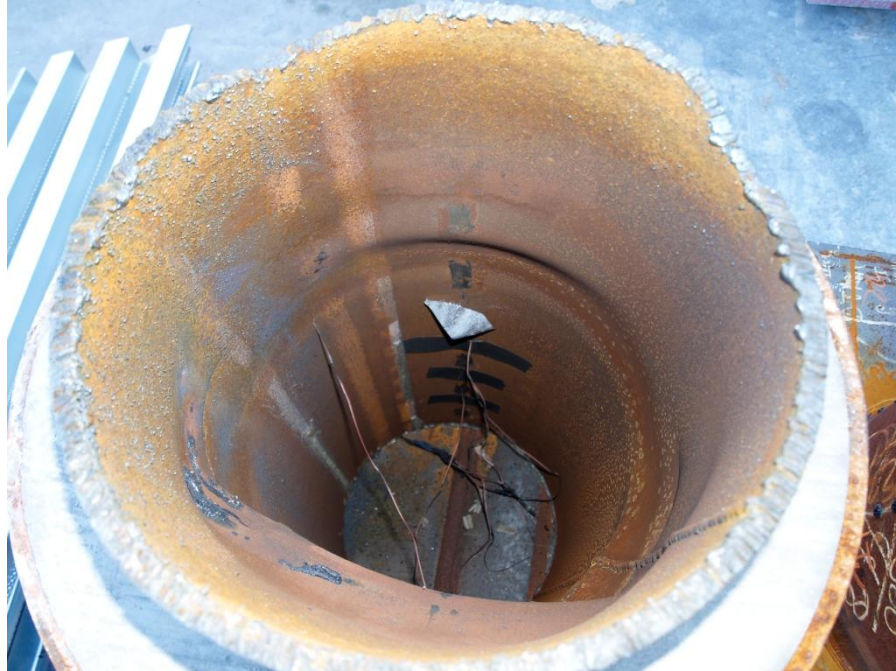
**Figure 6.165 Test 5 – Buckled Region inside HSS16x0.500**

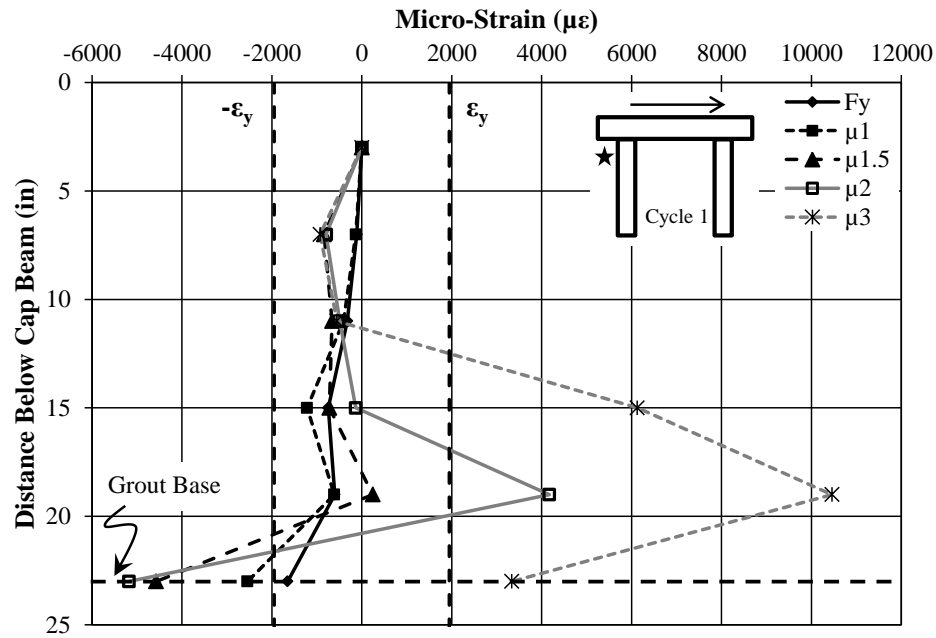
Figure 6.166 North Column North Face Connection Strain Elevation

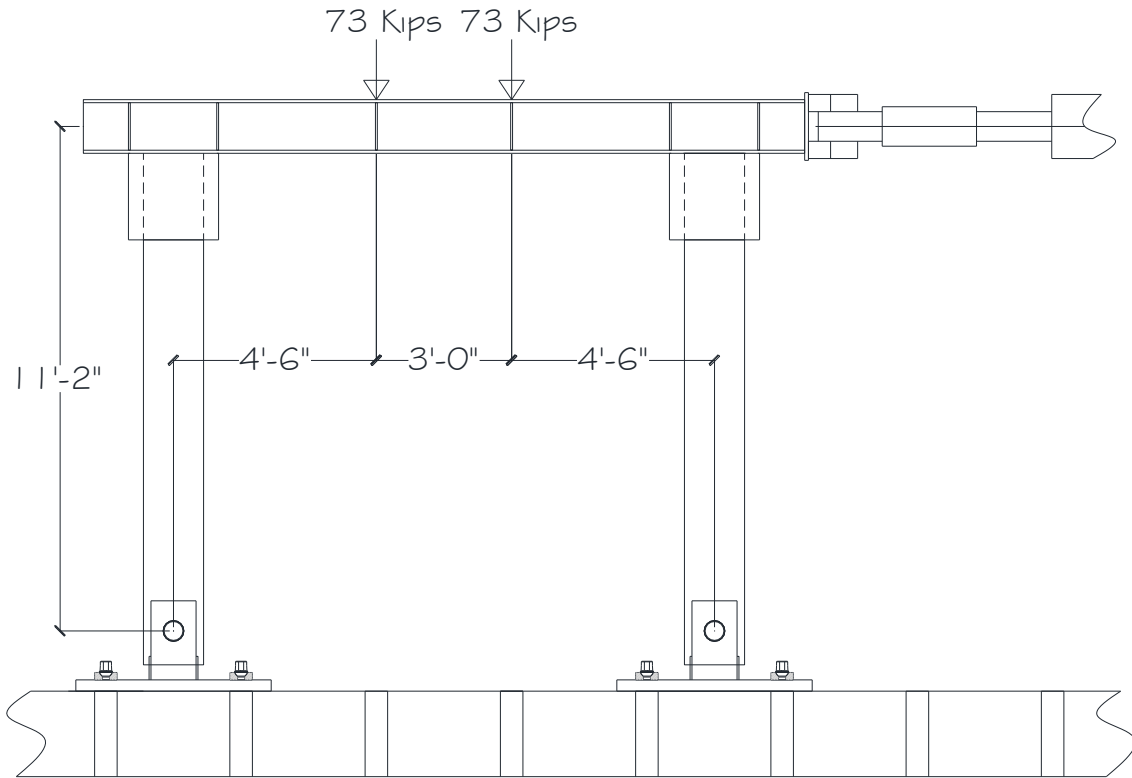
**Figure 6.175 Experimental Set Up with Vertical Dead Load**

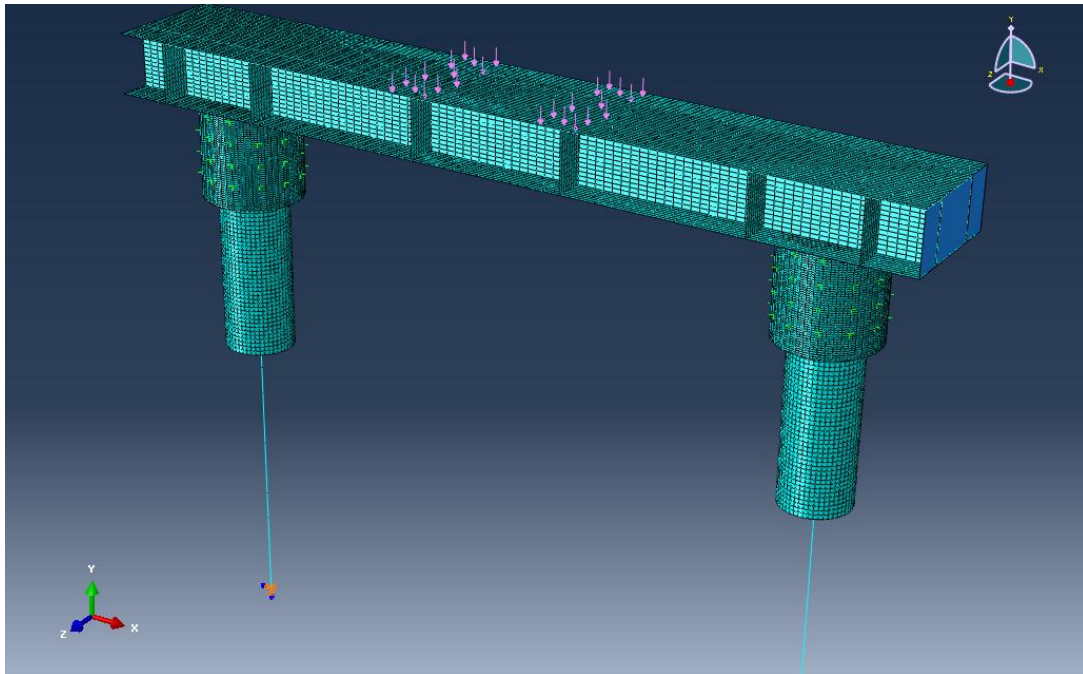
The model was subjected to a quasi-static lateral displacement history matching that of the test 2 experimental specimen as was the plan for the experimental test 6 evaluation which would be subjected to axial dead load, as has been discussed. The vertical load was applied in the model at the same two locations on the cap beam as would be done for the experimental test. As shown in Figure 6.178, the vertical load was applied at each location as a distributed load over an area of similar size as the spreader beams which would be used in the laboratory set up.

**Figure 6.178 Finite Element Model with Vertical Dead Load**

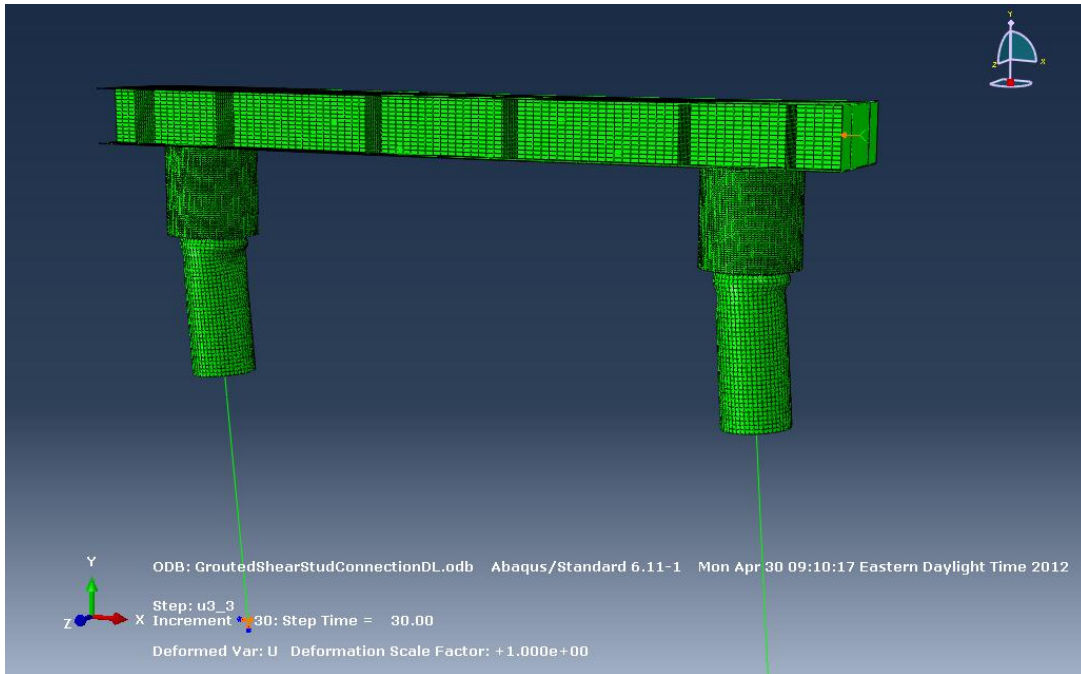
Figure 6.179 Pile Hinging of Displaced Pier – Ductility 3 Cycle 3

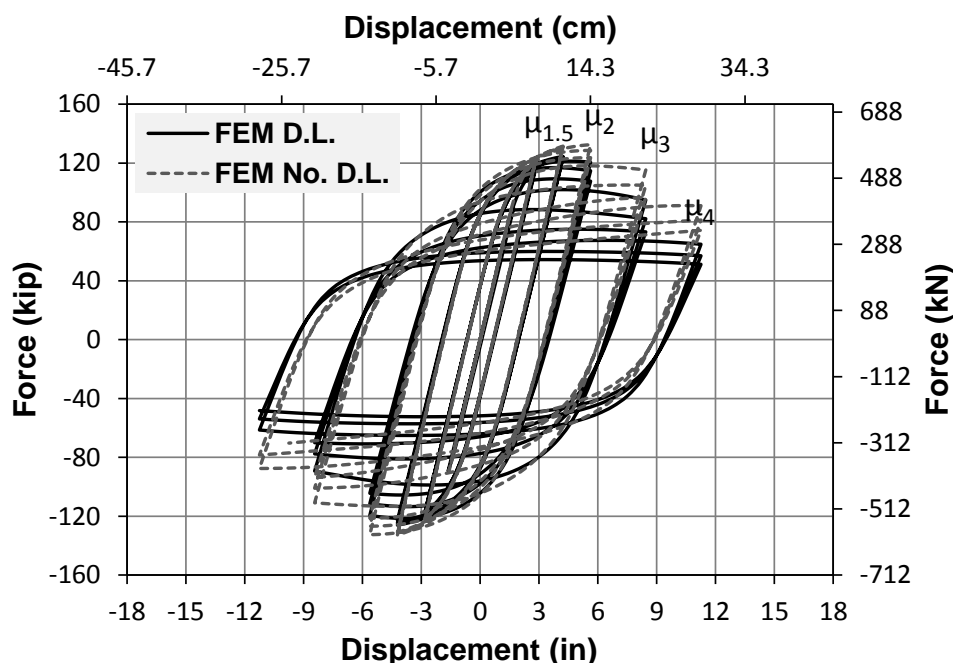
**Figure 6.181 FEM Hysteresis Comparison – D.L. vs. No D.L.**

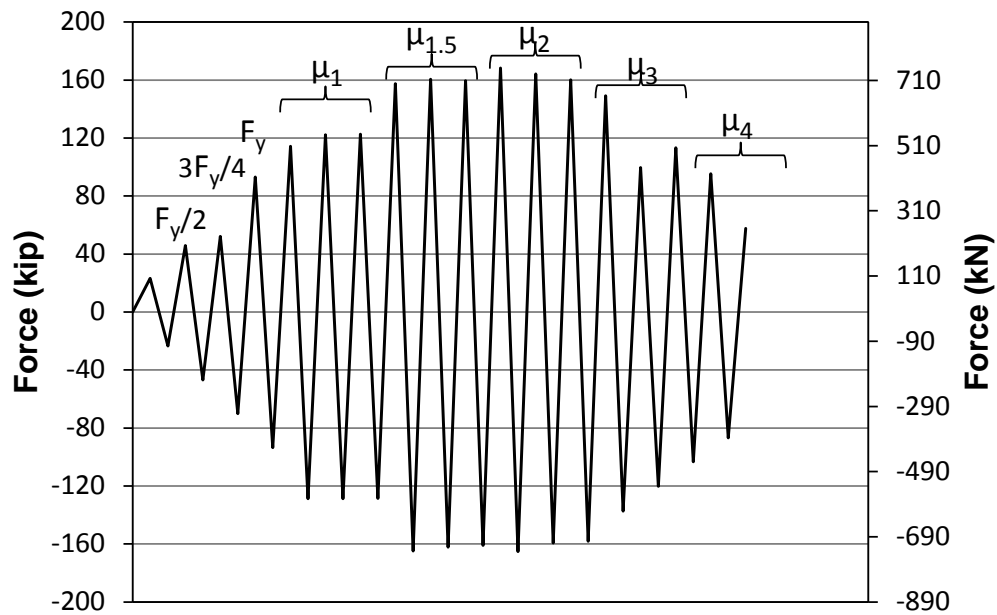
**Figure 6.182 Vertical Dead Load – G.S.C. Experimental Load History**
